Project No. 60095-72
March 16, 2017

Reference: *Cascade Shores Slide*

Subject: *Landslide Observations, Monitoring, Conclusions and Recommendations*

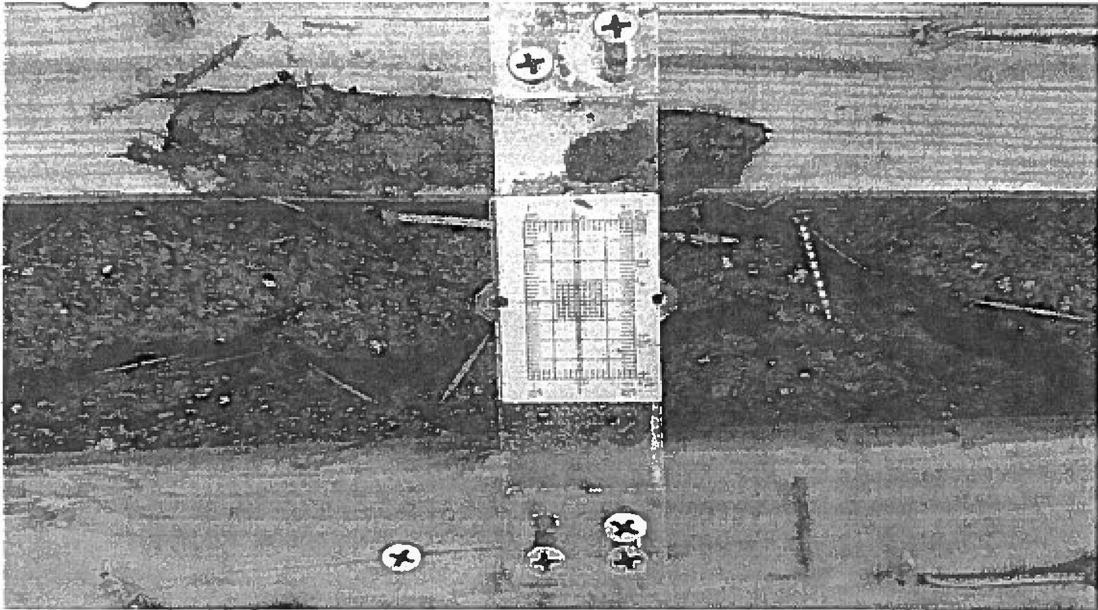
Photo 1 – Crack monitor on Mountain View Drive February 20, 2017.

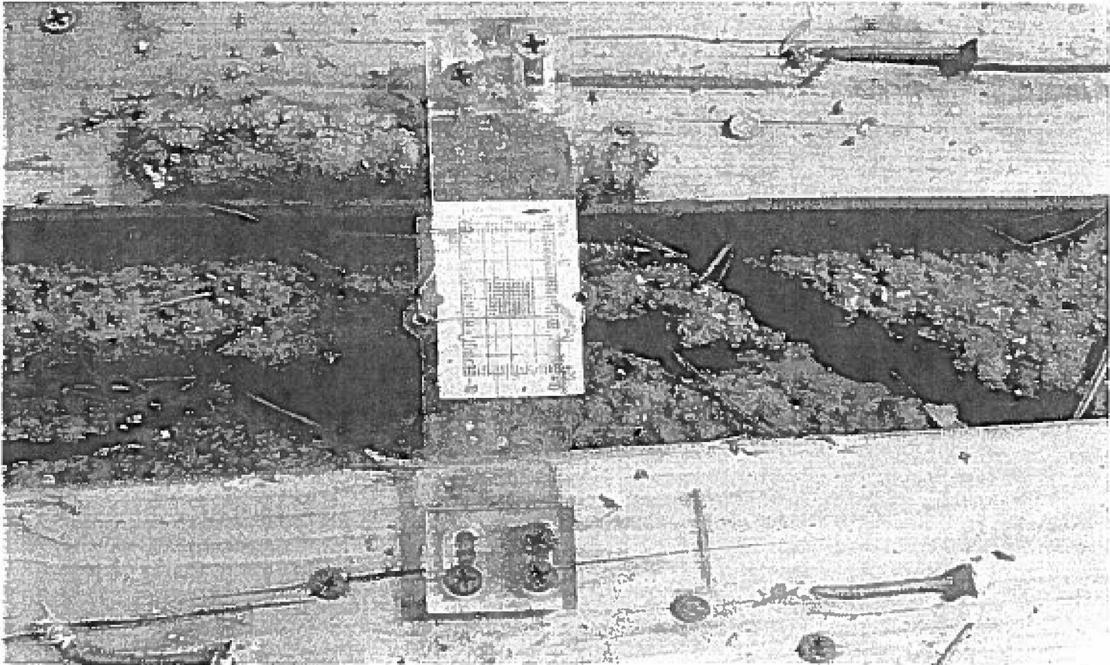
Since February 20th, the monitoring cracks on Mountain View Drive have expanded approximately 3 to 6 millimeters (mm), and staked tension cracks have expanded approximately 0.5 to 30 inches. A gap between the garage exterior wall and fence post on APN 38-340-18 has expanded approximately 1.25 inches. The vertical offset on the large scarp between the near vertical bluff and the residences on both Mountain View Drive and Pasquale Road is up to approximate 4.5 feet. Photographs are attached.

Photo 2 – Crack Monitor on Mountain View Drive February 28, 2017.

We recommend that slope inclinometers be installed up and down gradient of the cracks we have been measuring on Mountain View Drive. This would allow the County to monitor slope movement and the depth of the slide planes. The depth of

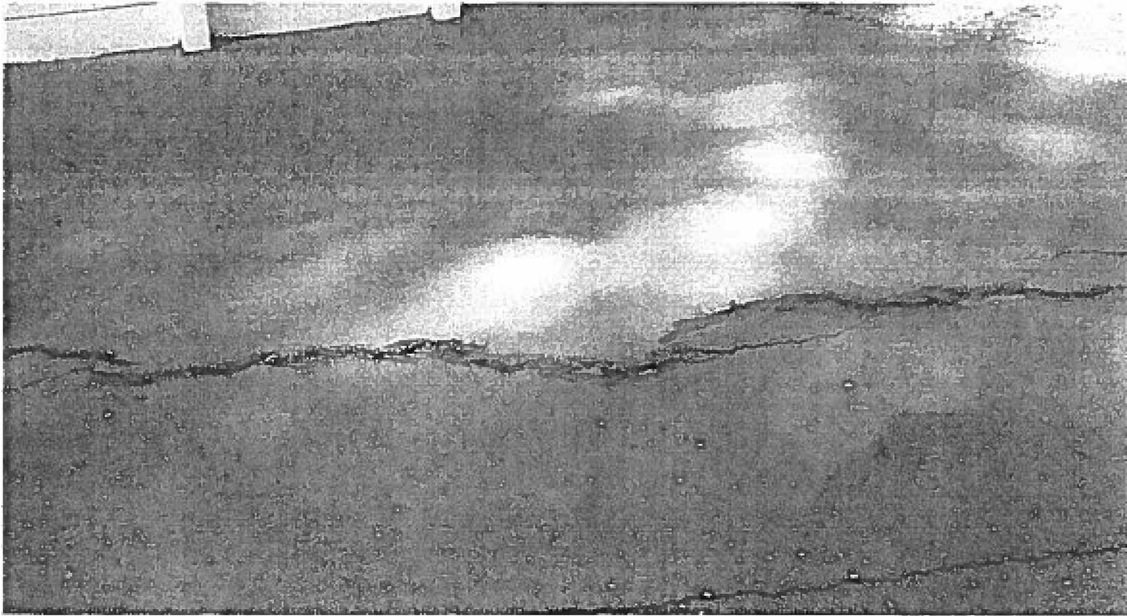
Photo 3 – Crack starting to form on driveway (APN 38-240-18).

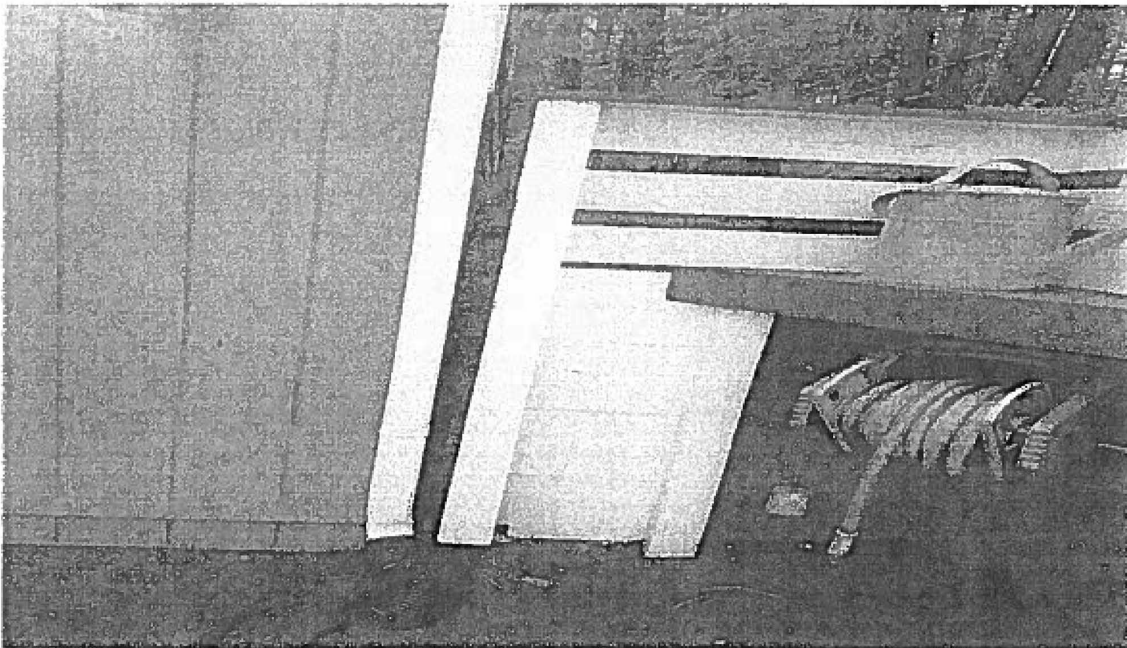
1. Since our site visit on February 24th, there has been minimal change observed to the residences on Pasquale Road (APNs 38-240-14, 38-240-15, 38-240-16, and 38-240-17). Monitored cracks, gaps, and stakes have indicated little to no slope movement since the heavy rains have subsided. Most of the observed damage to these sites appears to have occurred during and right after the heavy rain storm between February 20th and 24th. Based on Mountain View Road crack monitors and the gap between the garage and fence post located at the affected residence (see photograph 4 attached), the Mountain View Drive property (APN 38-240-18) has shown the most ground movement. The garage appears to be moving downslope, tilting away from the main residence.

Photo 4 – Garage tilting away from fence post (APN 38-240-18).

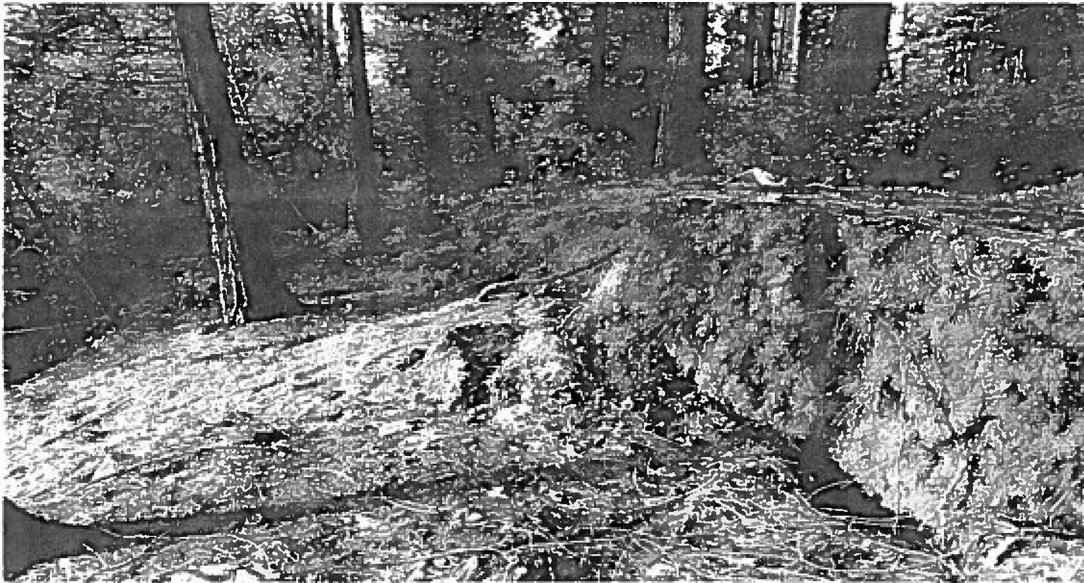
Photo 5 – Large scarp below Mountain View Drive property (APN 38-240-18).

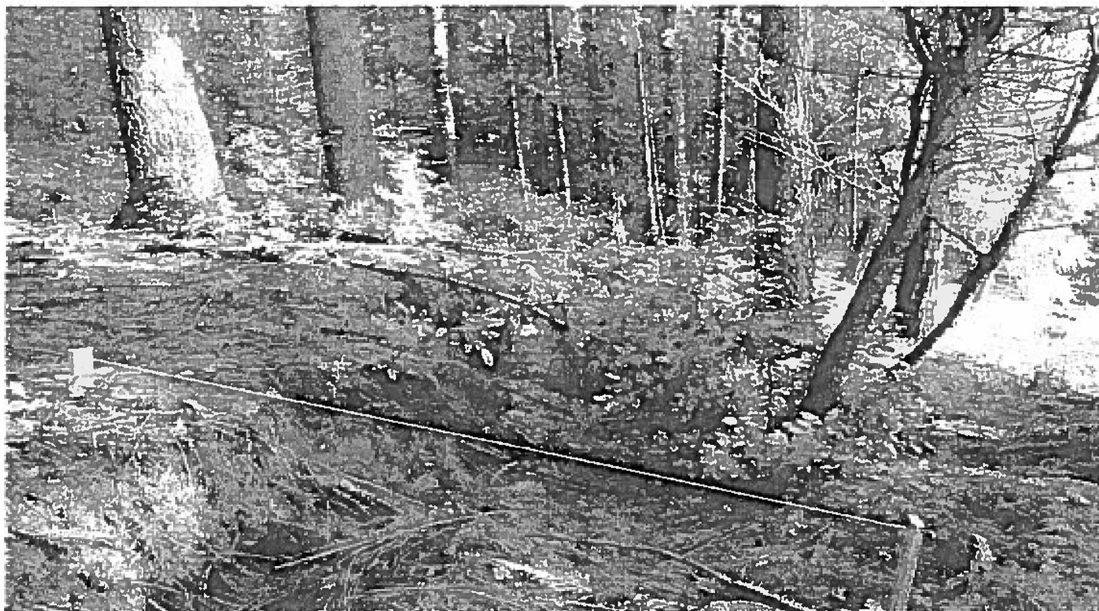
Photo 6 – Wooden stakes located below Mountain View Drive Property (APN 38-240-18).

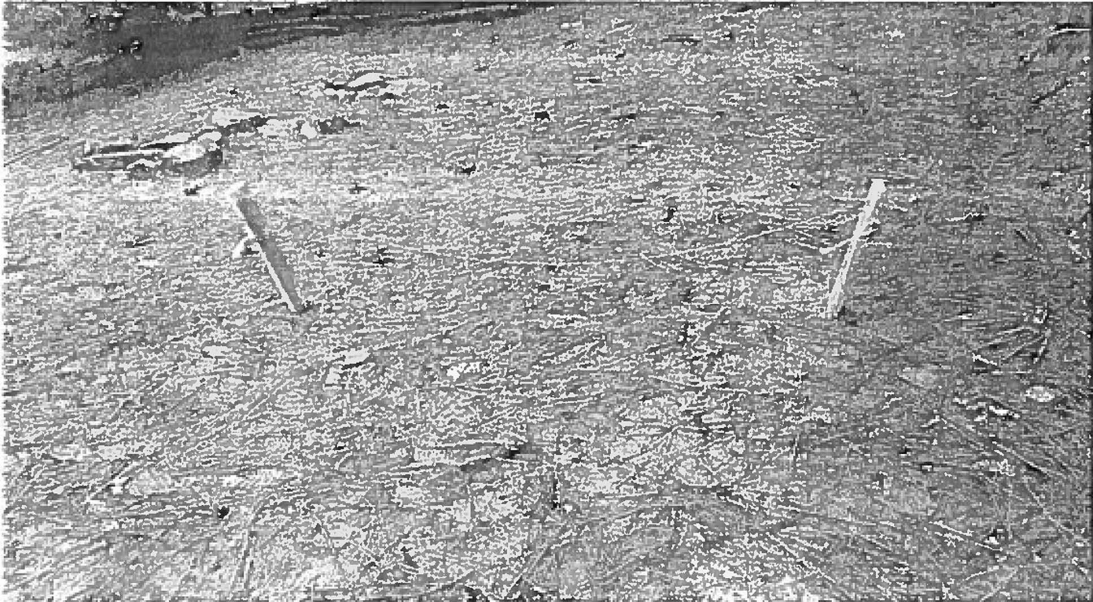
Photo 7 – Wooden stakes located below Pasquale Road.

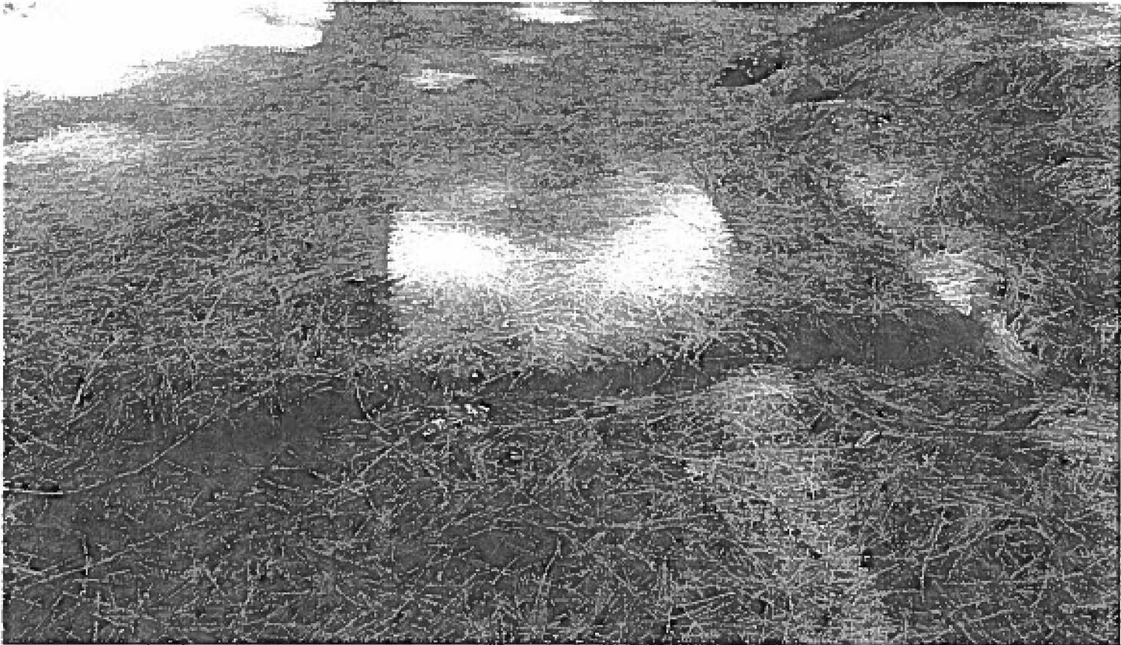
Photo 8 – Developing cracks below Pasquale Road.

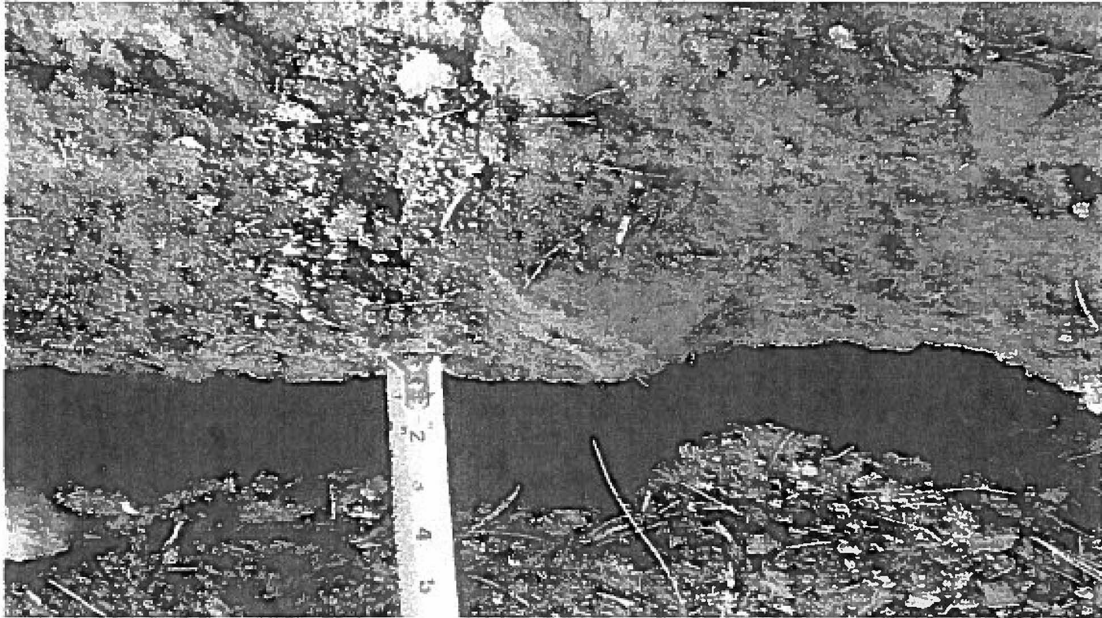
Photo 9 – Measurement of soil crack adjacent to Pasquale Road residence (APN 38-240-16).

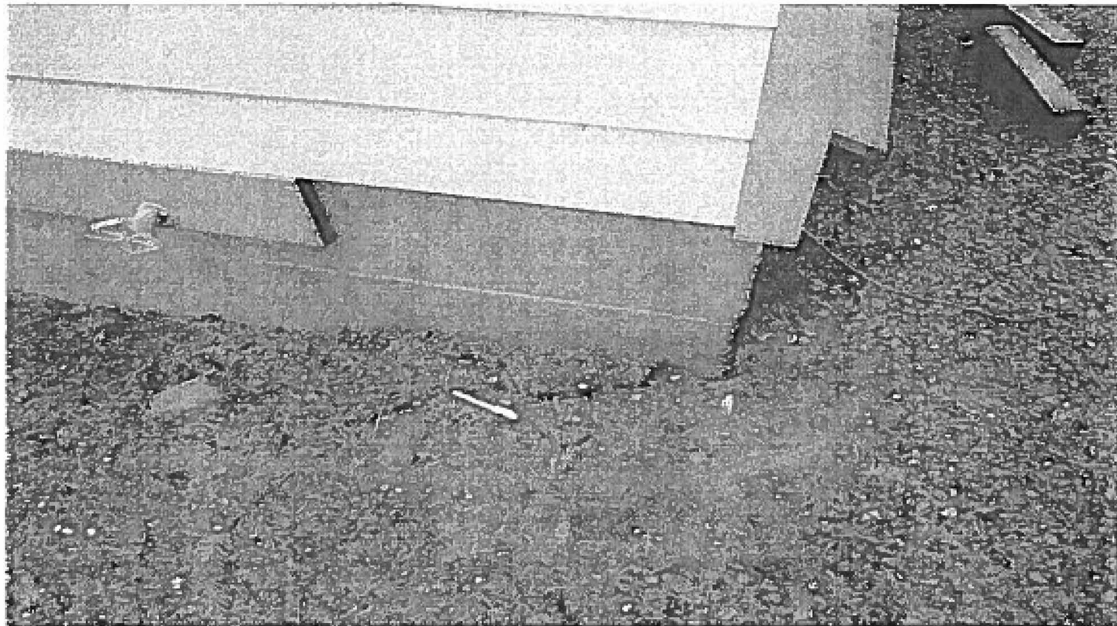
Photo 10 – Developing crack along foundation (APN 38-240-14).
