PUBLIC HEARING OF THE NEVADA COUNTY BUILDING & ACCESSIBILITY STANDARDS BOARD OF APPEALS

Appeal for a Technical Interpretation of the Building Standard Codes

Project Location: 17688 CHAMPION RD., NEVADA CITY

THE DECK IN QUESTION, HOW THE CONCERNS HAVE BEEN ADDRESSED

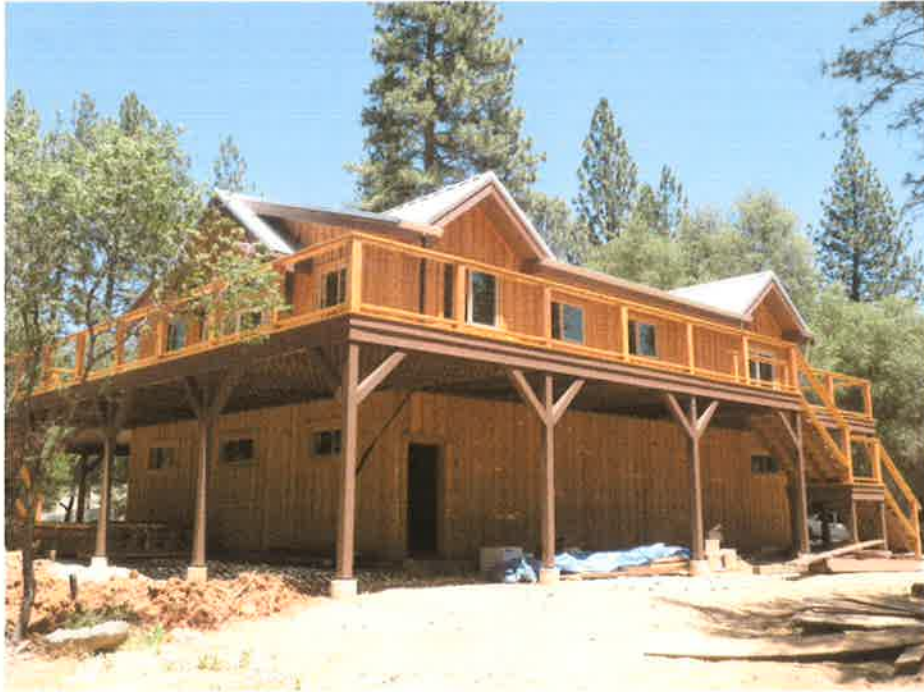
36 posts are subject to the ruling.

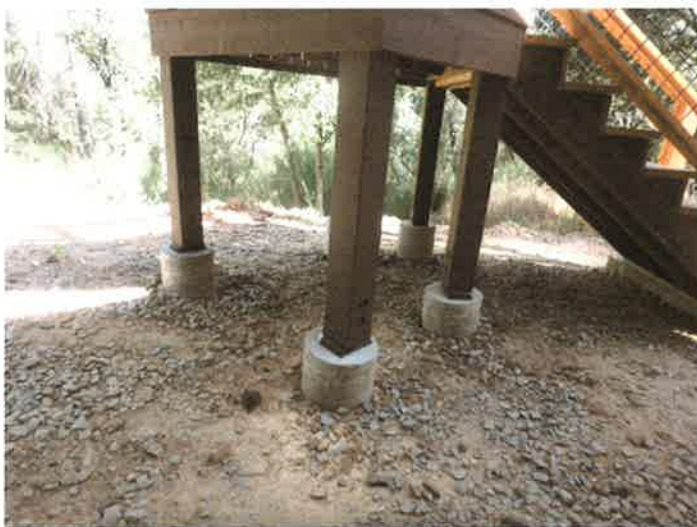
Every post is elevated on the concrete piers

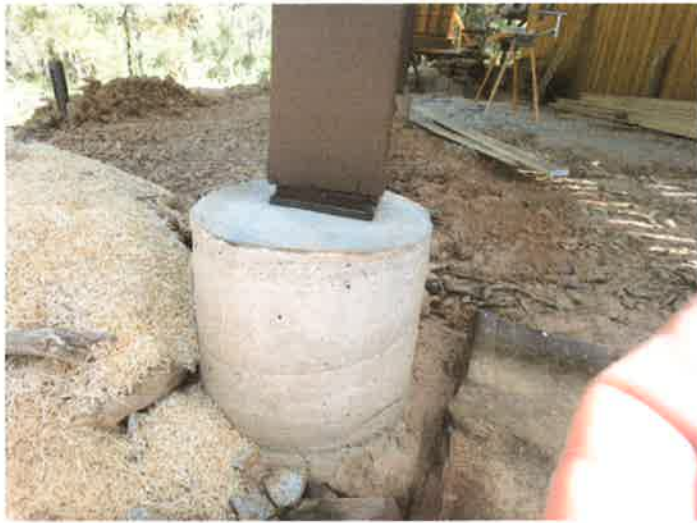
Every post is set on a metal stand-off base.

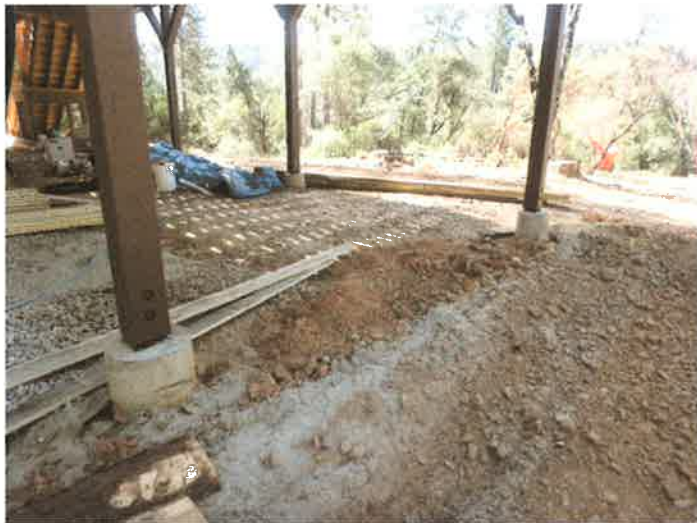
A concrete slab will extend past the piers.

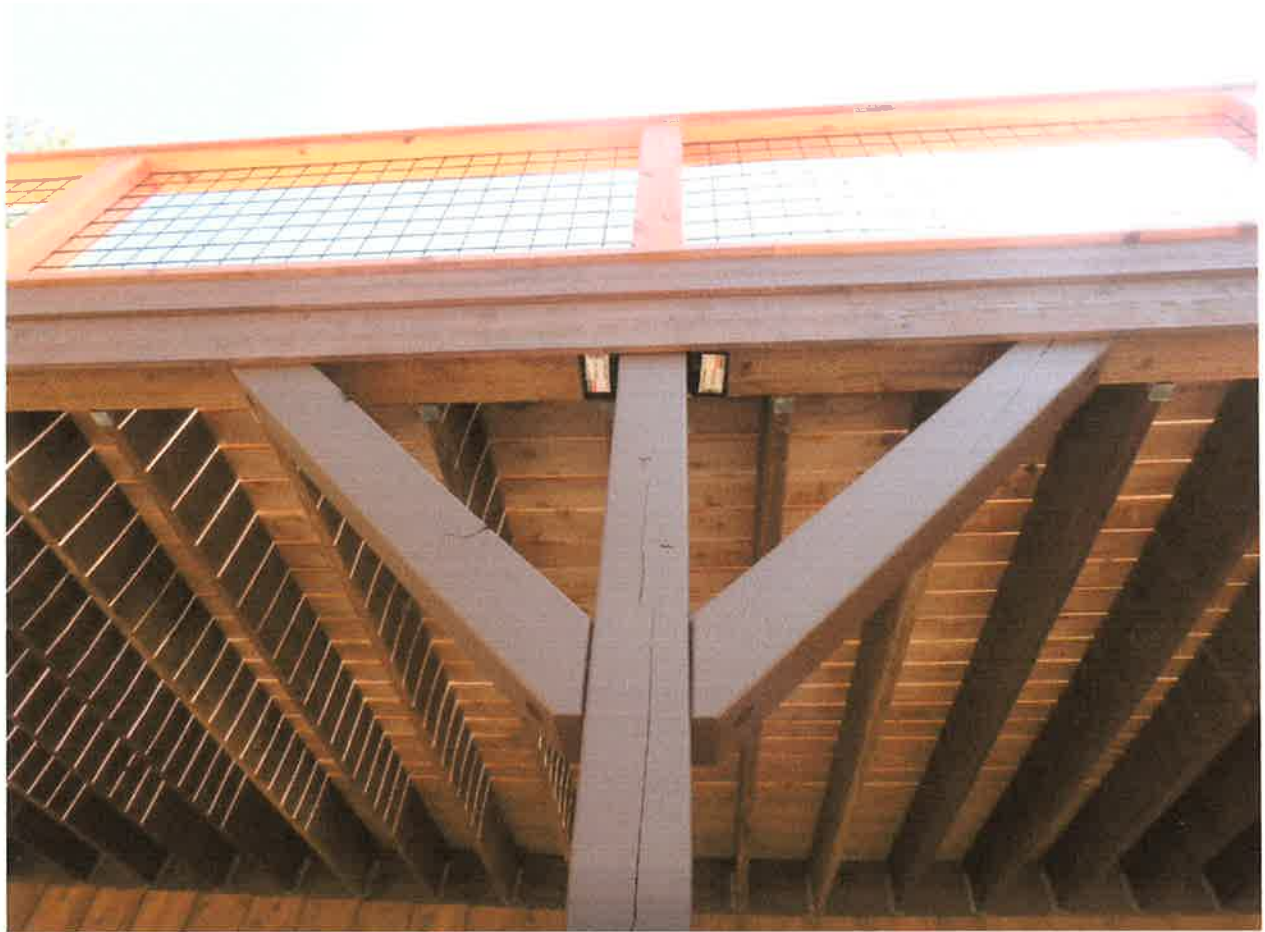
The tops of the posts are protected, not subject to decay by water absorption. The upper level posts are overlapped by the rail cap 1", the lower posts have 3 layers of material providing 2 ½" of overhang protection. All of these materials, (Rail cap, Fascia , decking), are cedar, an approved species for decay resistance.

The Plan Checker at the Building Department offered that one solution would be to provide a roof over the deck that extends 1" beyond the edge of the deck. The As-built construction provides better protection than that.

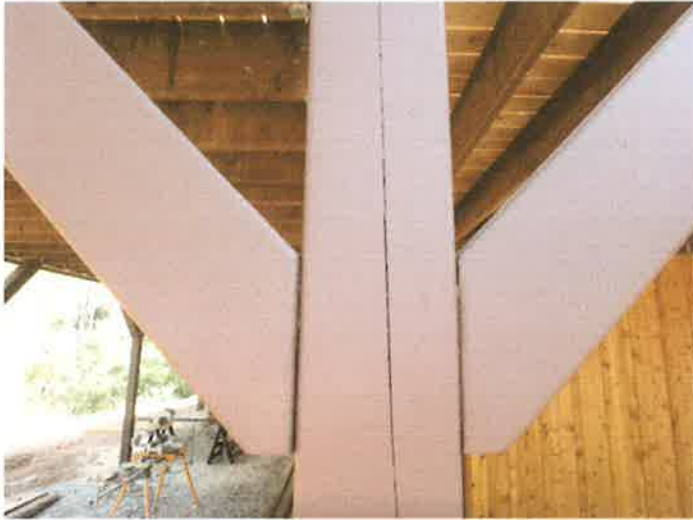
2. The Code the Building Department has chosen to apply, R314.1.3, is met in every regard with the exception of the joint where the knee braces connect to the posts, and we have a way of addressing that concern with a flashing.

This joint is the only location that is subject to water getting places it shouldn't.
