# HUMBUG CREEK WATERSHED ASSESSMENT AND MANAGEMENT RECOMMENDATIONS

*A pilot assessment of mining impacts and recommendations for action  
to improve water quality at Malakoff Diggins State Historic Park*

The Sierra Fund

April 2015

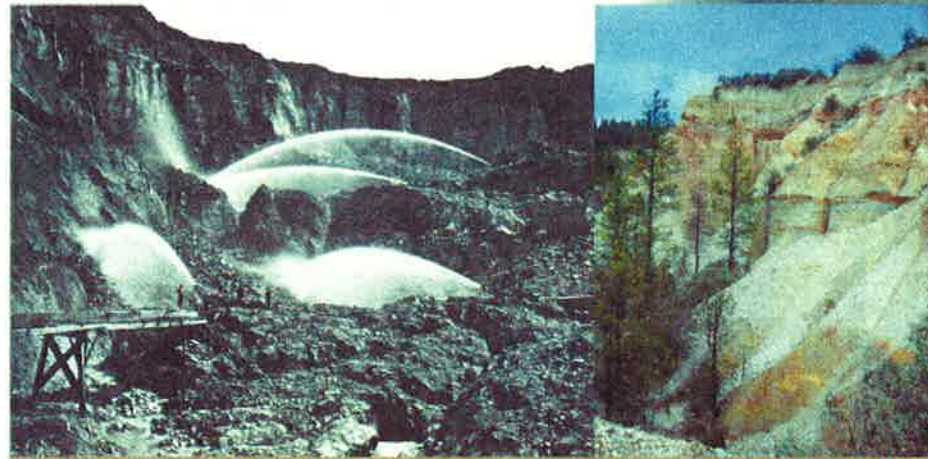
**The Malakoff Diggins Mine Pit - Then and Now:** Hydraulic mining monitors were used to direct powerful streams of water to wash down hillsides in search of gold bearing gravels. Seven monitors ran day and night and large amounts of mercury were used to extract gold from the resulting slurry. Today, the steep walls left by the mine continue to erode, and in large rainstorms as much as a ton of sediment can be carried downstream.

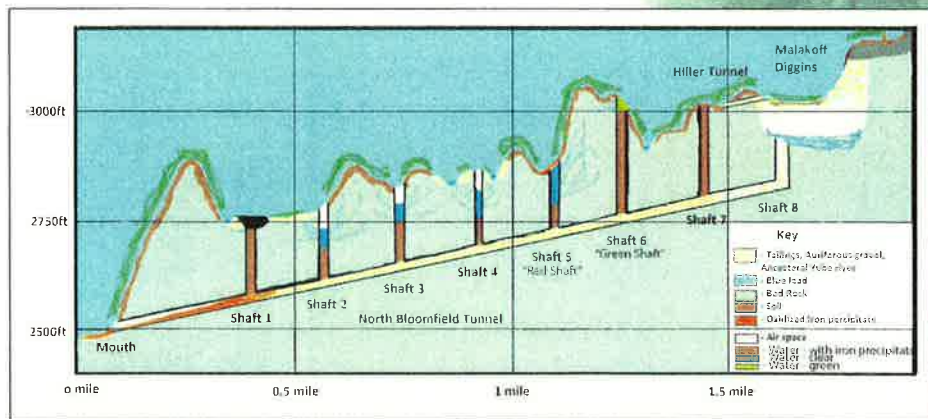
**North Bloomfield Tunnel:** This illustration presents the current understanding of the 7,847 ft North Bloomfield Tunnel and access shafts. The tunnel was built to drain the Malakoff Diggins pit during peak mining operations (1874-1884), but is currently blocked and has minimal discharge to the watershed.

2. Discharge from Shaft 5 can be addressed by constructing a boardwalk to re-route the Humbug Creek Trail around Shaft 5. A long-term management strategy to treat the water and metals discharge at Shaft 5 would necessitate monitoring the outflow both at Shaft 5 and the North Bloomfield Tunnel outlet to determine permitting requirements.

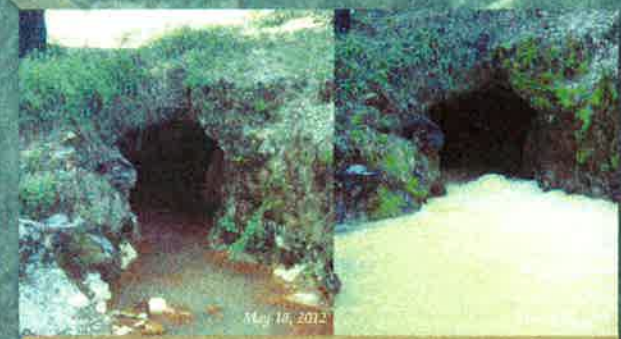
**Hiller Tunnel Discharge at Low and High Flow:** Hiller Tunnel is the only visible surface water discharge location of the Malakoff Diggins pit. It has year round flow, and discharges vast amounts of turbid water during storm events.

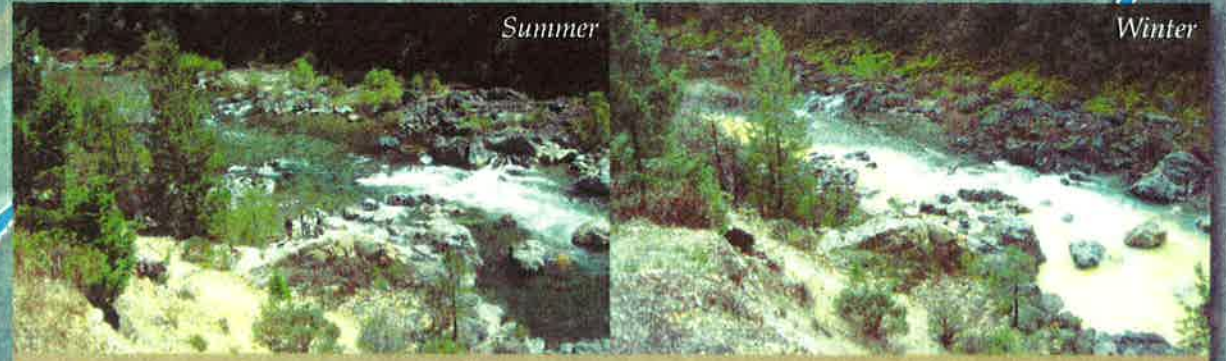
**Confluence of Humbug Creek and the South Yuba River: Summer and Winter:** Humbug Creek enters the South Yuba River at the top left of these photos. In the summer (left) there is no visible discharge, but in the winter after a storm event the mixing zone of turbid water from Humbug Creek into clear water from upstream in the South Yuba is apparent. The turbid water continues at least ten miles downstream.

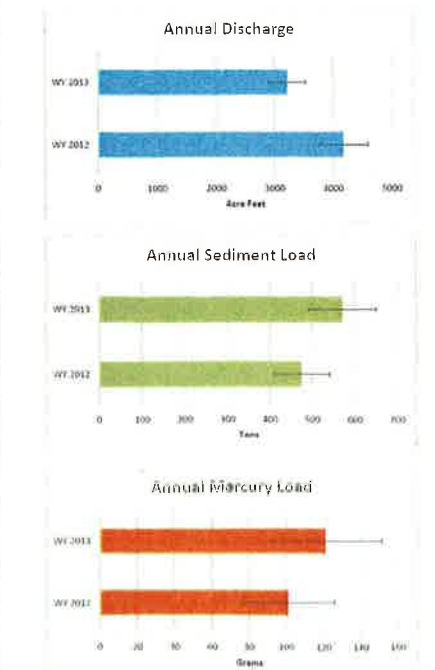
HUMBUG CREEK ANNUAL LOAD ESTIMATES

1. The Malakoff Diggins pit drains via Diggins Creek and contributes sediment and particulate bound mercury, and other metals to Humbug Creek.
2. **Humbug Creek contributes an estimated 500 tons of sediment and an estimated 100 g of mercury to the South Yuba River per year, during a dry or below normal year.**
