PUBLIC HEARING OF THE NEVADA COUNTY BUILDING & ACCESSIBILITY STANDARDS BOARD OF APPEALS

Appeal for a Technical Interpretation of the Building Standard Codes

Project Location: 17688 CHAMPION RD., NEVADA CITY

THE DECK IN QUESTION, HOW THE CONCERNS HAVE BEEN ADDRESSED

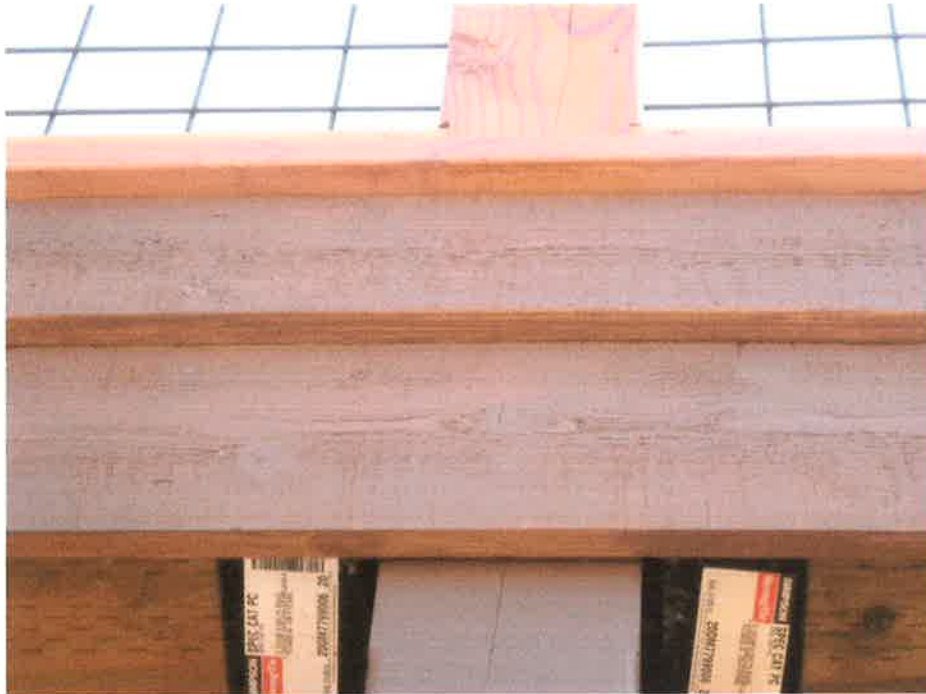
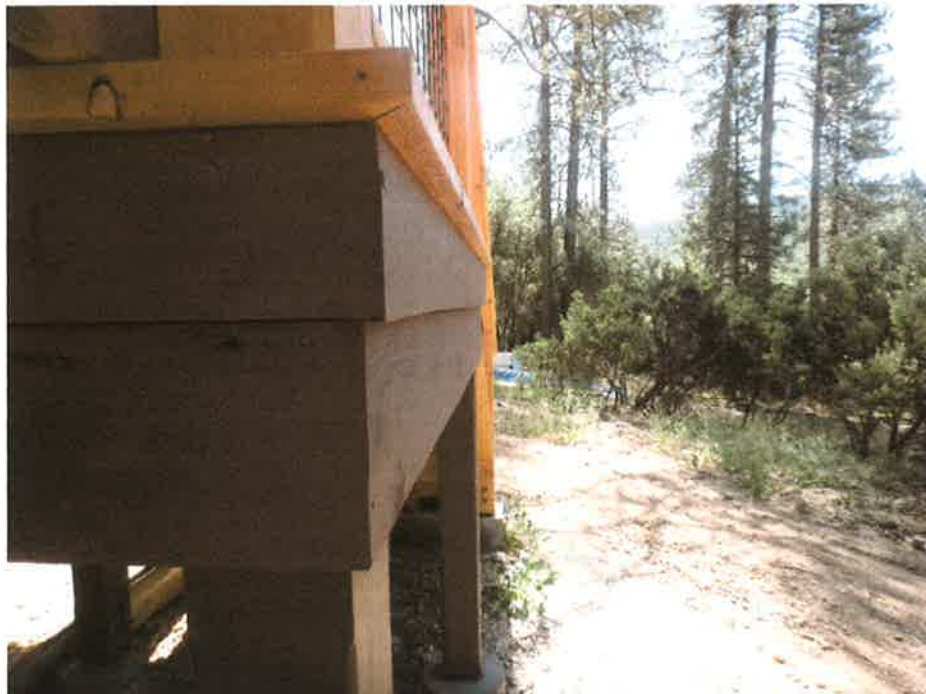
The tops of the posts are protected, not subject to decay by water absorption. The upper level posts are overlapped by the rail cap 1", the lower posts have 3 layers of material providing 2 ½" of overhang protection. All of these materials, (Rail cap, Fascia , decking), are cedar, an approved species for decay resistance.

This joint is the only location that is subject to water getting places it shouldn't.

A metal flashing can be provided to prevent infiltration, protect against decay.
