# Van Norden Meadow Restoration & Recreation Project

Purpose and Need and Proposed Action

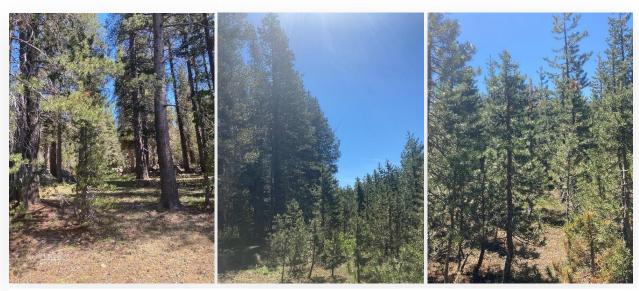
Figure 4: Van Norden forested area on edge of meadow (left). An area where forest edge and meadow encroaching conifers meet (middle). Conifers that have encroached into the meadow (right).

Up to 120 acres of conifers (primarily lodgepole and some white fir) would be removed or thinned to restore the meadow surface, aspen and the surrounding forest. Within the Project area conifers would be removed using hand or mechanized equipment including but not limited to: feller bunchers, skidders, chippers, masticators, end or long lining, tracked and rubber tired machinery, and other typical aerial or ground-based logging machinery. Conifers may be disposed of through: chipping, hand or grapple piling for burning, mastication, decking for public fuelwood cutting, sold as commercial fuel wood, biomass removal, and/ or incorporation into fill material for stream

restoration activities. Conifers would be completely severed below the lowest live branch to a maximum height of 8 inches above the surface. The area would be allowed to revegetate naturally.

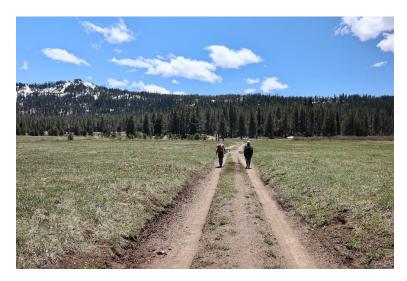
Figure 5: Hikers walking along the meadow bisect road.

Construct low water crossings or install culverts at drainages and add fill along approximately 0.12 miles of road to improve hydrologic connectivity and reduce sediment delivery from road. Decommission approximately 0.27 miles of road within the meadow and replace with a 240-foot bridge and 0.05 miles of road on the meadow to allow for hydrologic connectivity. Re-align/construct 0.22 miles of road on the upland glacial moraine to retain connectivity with PG&E Road and trails system.

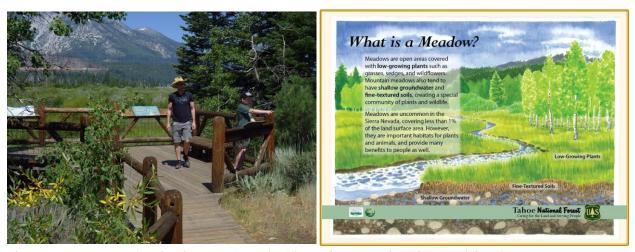
Figure 8: Example of a viewing platform (left) and interpretive signage (right)

Viewing platforms with interpretive signage will be incorporated into the trail design to enhance birding and wildlife viewing opportunities that are accessible to a diverse array of recreationists. These platforms will be wood/metal construction and will include a space to sit. The platforms will create a more immersive experience for trail users who will access platforms from the trail and will encourage users to stop, rest, and experience the meadow and surrounding landscape. Viewing platforms will be placed at several locations within the meadow, including: the old dam berm, within the conifer encroachment area on the north side of the meadow, and on the south side of the meadow bisect road (see maps in Appendix A, Figure 11).

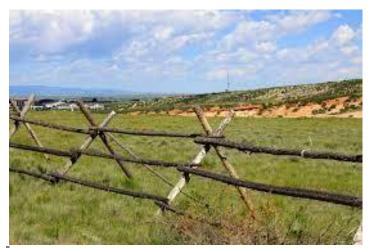
Figure 9: Example of buck and rail- style fencing that is built to withstand snow loads.

resources and sustainable recreation access. Fences will be constructed using natural materials such as lodgepole pine poles harvested onsite, cedar split rails or other wood poles and constructed to withstand heavy snow loads.

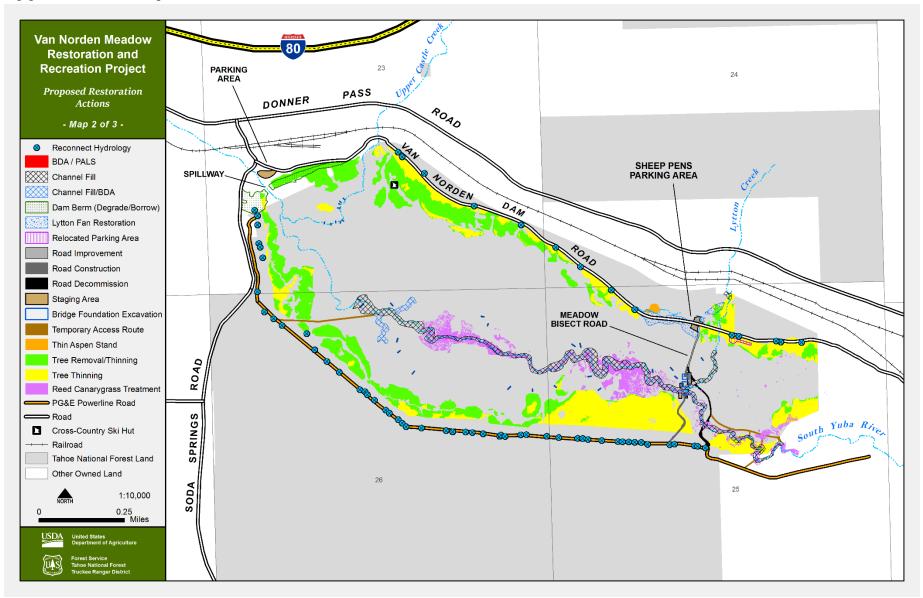
Figure 10: Map of Van Norden Meadow Restoration actions.

Within the "Conifer Encroachment zone" (see maps in Appendix A, Figure 10), all conifers would be removed except in the area of the Royal Gorge cross-country ski trail where the following prescription would be applied.

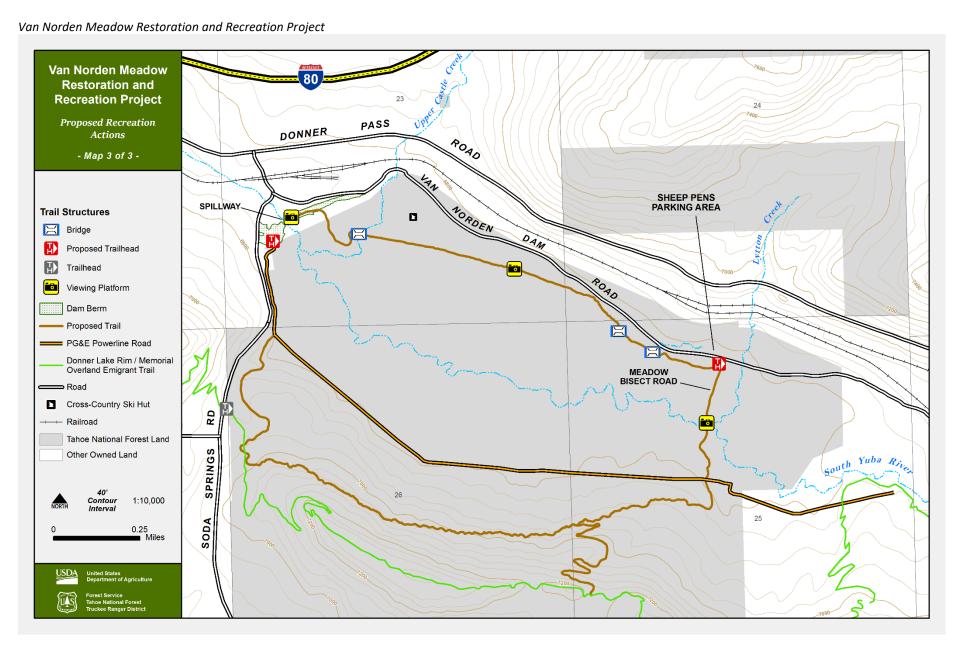
Figure 11: Map of Van Norden Meadow Recreation improvement actions.

An additional trailhead and parking area would be constructed on the north side of the meadow near the old sheep pins area (see maps in Appendix A, Figure 11). This area is currently used as a parking area but in its current location disrupts Lytton Creek's hydrologic flows. Relocating the existing parking lot 1/10 of a mile to the east along the Van Norden Dam Road would reactivate the alluvial fan and meet the meadow restoration goals as described on page 8 and 9.
