Re: Evaluation of a Potential Ephemeral Drainage/Stream within the Frontage Area of a Parcel Located at 17860 Cattle Drive in Rough and Ready, Nevada County

(APN: 51-110-04)

Photos of March 13th and 28th, 2019 Field Surveys of the Proposed Parking Area

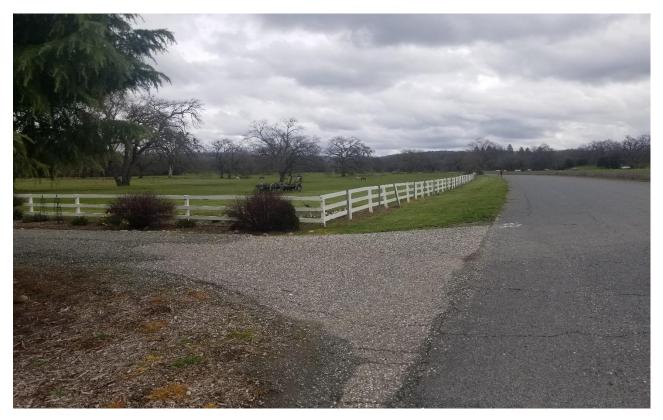
Photo 1: Entrance to the subject parcel along Cattle Drive with proposed parking area in the background. No ephemeral drainages or streams were identified in or adjacent to the parking area.

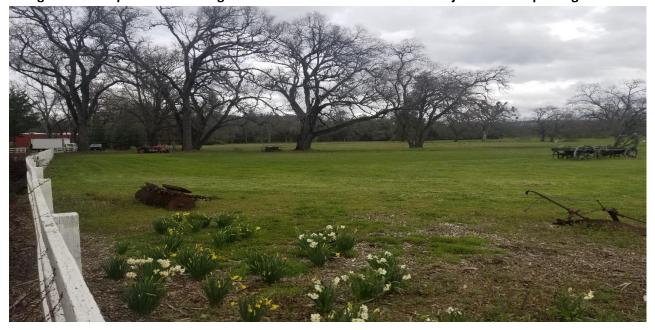
Photo 2: Proposed parking area in the background. No ephemeral drainages or streams were identified within or adjacent to the parking area. A stream is located behind the large oak trees.

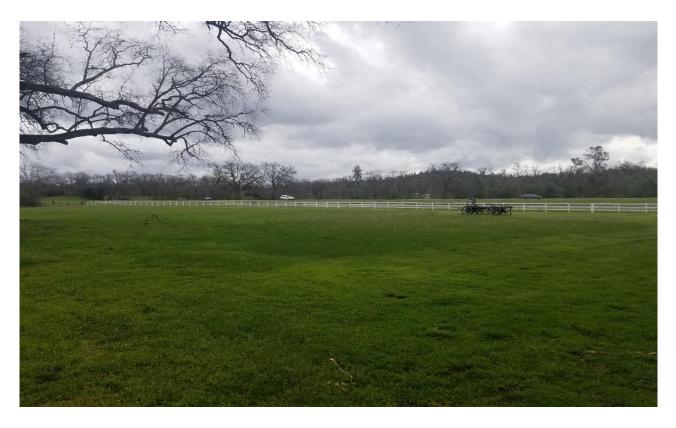
Photo 3: Proposed parking area. No ephemeral drainages or streams were identified within the proposed parking area.

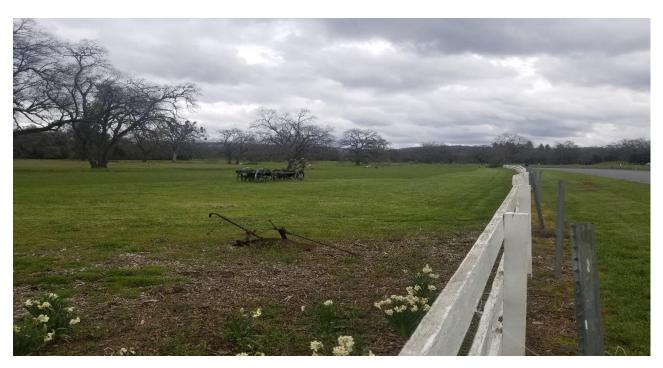
Photo 4: Entrance to the subject parcel along Cattle Drive with proposed parking area adjacent to fence line. No ephemeral drainages or streams were identified in or adjacent to the parking area.

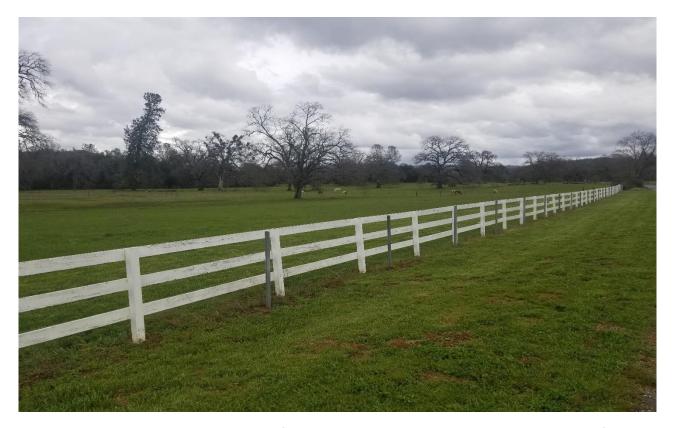
Photo 5: Proposed parking area within the fence line along Cattle Drive. No streams were identified within or adjacent to the proposed parking area.

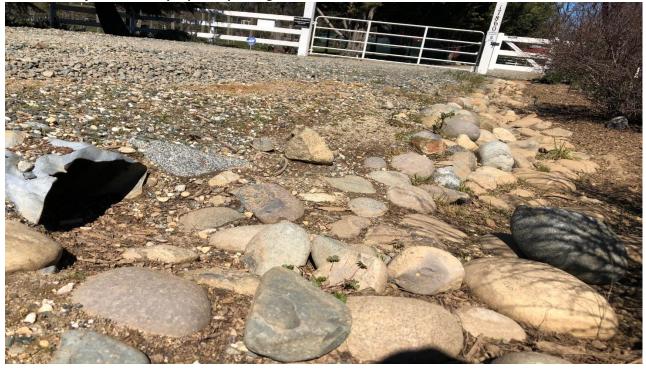
There is low rock lined area immediately adjacent along the western and eastern edges of the gravel driveway off of Cattle Drive and there is a small culvert (approximately 8 inches in diameter) located at the entrance to the subject parcel as you enter off of Cattle Drive (see attached photos). The small culvert appears to allow small amounts of water that drain off the gravel driveway to flow into a small puddle area located on the western edge of the gravel driveway where the existing culvert is located. The small culvert and drainage along the gravel driveway do not constitute an ephemeral stream or any other type of stream given that the drainage does not contain a defined bed and bank, ordinary high water mark, and a direct connection to another stream (see attached photos). Therefore, there are no stream features within the entrance to the subject parcel or within the proposed parking area that would be defined as a stream and therefore, would not be subject to Nevada County regulations requiring a Management Plan for encroachment into the non-disturbance buffer of a stream.

Photo 6: Rock lined driveway drainage and culvert. Drainage feature is not a stream. Does not contain defined bed and bank, ordinary high water mark, or connection to any other stream up/downstream.

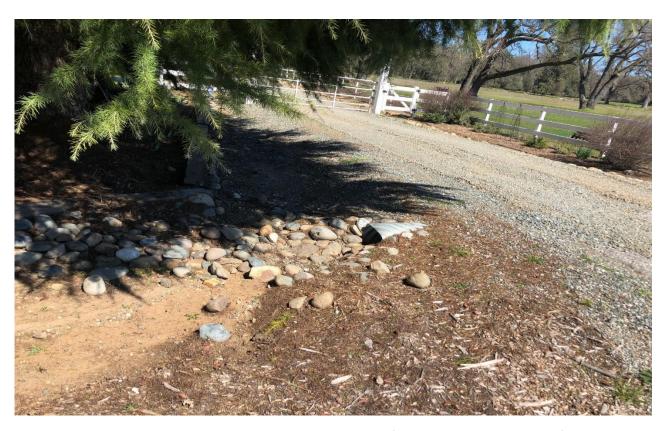
Photo 7: Rock lined driveway drainage with culvert. Drainage feature does not contain defined bed and bank, ordinary high water mark, or a direct connection to any other stream up/downstream.

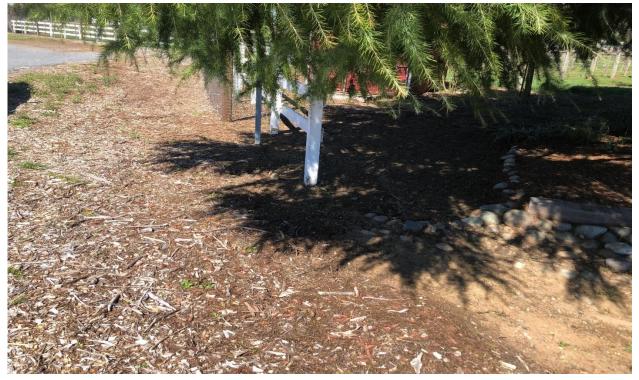
Photo 8. East of rock lined driveway drainage with culvert. Drainage feature is not a stream. It puddles along western side of entrance to subject parcel.
